Diagnosis of Production Facilities of Bandsaw Mills by Sawing Accuracy : Investigative report at Norwegian bandsaw mills

—Investigative report at Norwegian bandsaw mills—

Nobuaki HATTORI

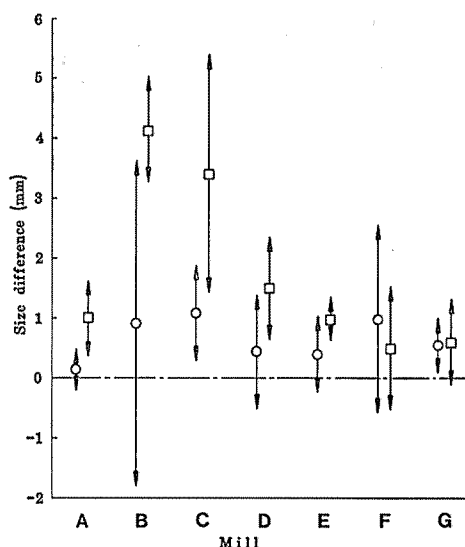
Fig. 11 Size difference from target size at each mill. \circ mean of size differences for thickness and \square mean of size differences for width. A line with arrow heads indicates ± 1 standard deviation.

Information about size difference from target size is shown in Figure 11 where mean values of size differences from the target thicknesses and widths are indicated with their standard deviations. Each data set was recognized to have a normal distribution. An F-test to compare variances of size difference for thickness and width from the target sizes found that all mills except Mills D and F had differences between the two variances. Two kinds of t-tests were performed in order to compare the mean values of thickness and width differences from the target sizes. As a result, Mills F and G were recognized significantly (1 %) to produce lumber with the same grade of size difference

from the target size for thickness and width. Other mills seemed more or less to produce lumber with different size difference. In particular, Mills B and C seemed to produce lumber which have widths much more oversized than the thickness. Because of this large variation, the machines in the mills have been adjusted to produce oversized lumber in order to insure acceptable finished sizes. Only Mill F could be evaluated to produce lumber with the same grade of size differences between thickness and width from the standpoints of the mean value and the standard deviation. From these results, it became clear that machine adjustments are set with larger oversize for the primary sawing (decision of width) than for resawing (thickness) at all bandsaw mills which were judged to produce lumber with different size variations of thickness and width.
